**AVIATION INVESTIGATION REPORT**  
**A01P0126**

**LOSS OF SEPARATION**

**NAV CANADA**  
**VANCOUVER AREA CONTROL CENTRE**  
**DUXAR INTERSECTION, BRITISH COLUMBIA, 110 NM NW**  
**08 JUNE 2001**

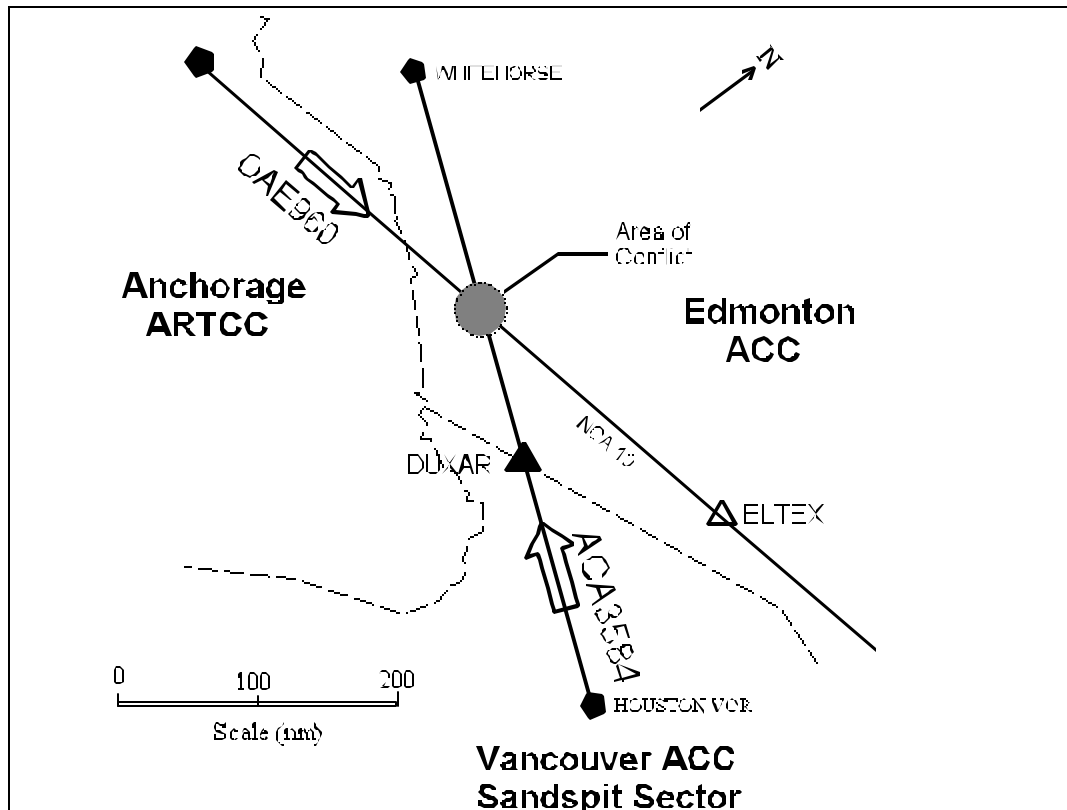
The B737 (ACA3584) was proceeding to Whitehorse via the Houston VOR (very high frequency omnidirectional radio range) and the DUXAR intersection at a cleared altitude of FL310. It crossed the Northern Control Area Route 10 (NCA 10) about 110 nautical miles (nm) northwest of the DUXAR intersection. This intersection is at the airspace boundary between the Vancouver and Edmonton ACCs. (See Figure 1.) Between the Houston VOR and DUXAR, the aircraft was under the control of the Sandspit sector of Vancouver ACC.

Figure 1. Flight paths of ACA3584 and OAE960
